Scanning Induction Hardening of Steel Coupler

DANTE Solutions, Inc.

Problem Statement:
Thick-walled coupler of 4130 steel suffered axial cracks along a bore fillet during spray quenching following scanning induction heating.

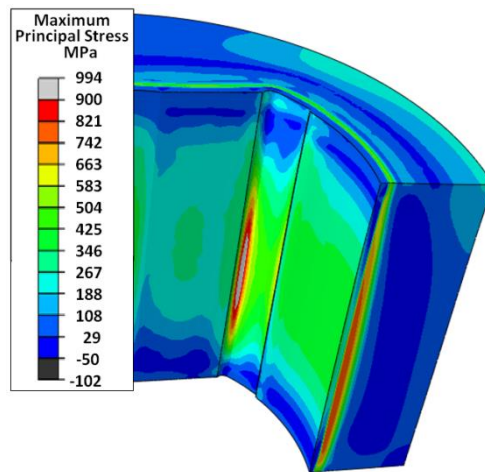
Crack in Fillet

Maximum principal stress is highly tensile in the fillet corner where cracking occurs due to a high bending moment present as martensite forms during conventional process.

Benefits:
By changing the process to include a low temperature preheat step:

- the surface tensile stresses during quenching were reduced;
- the final residual compressive stress gave improved part performance; and
- cracking problems were eliminated.

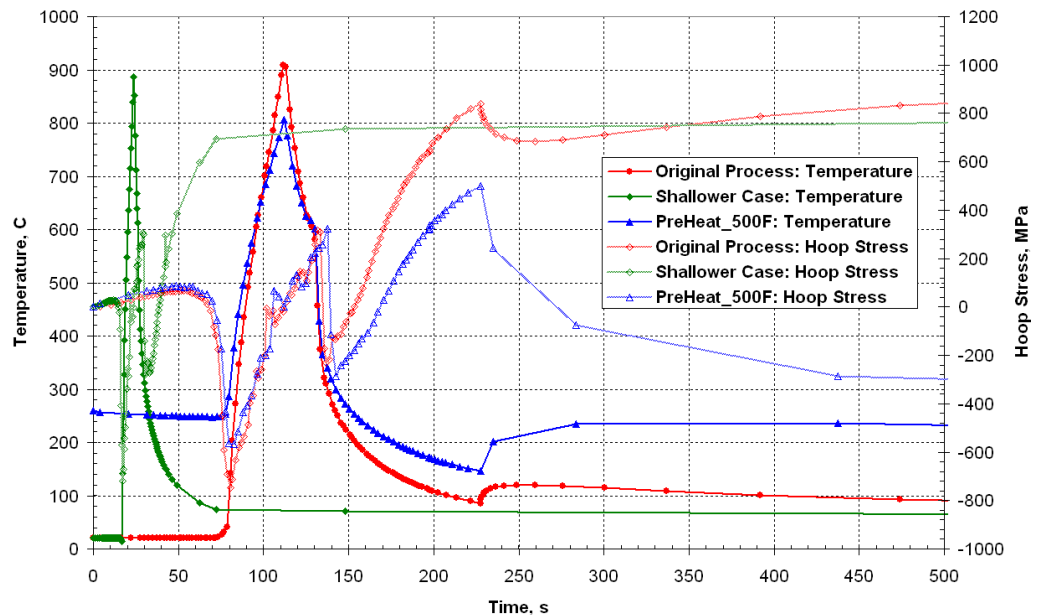
Time history plots comparing temperature and hoop stress for baseline process and process with initial preheat. Preheat decreases in-process hoop tension and leaves beneficial residual compressive hoop stress.
